Revised draft following consultation

Millom Castle Conservation Area Appraisal

June 2023

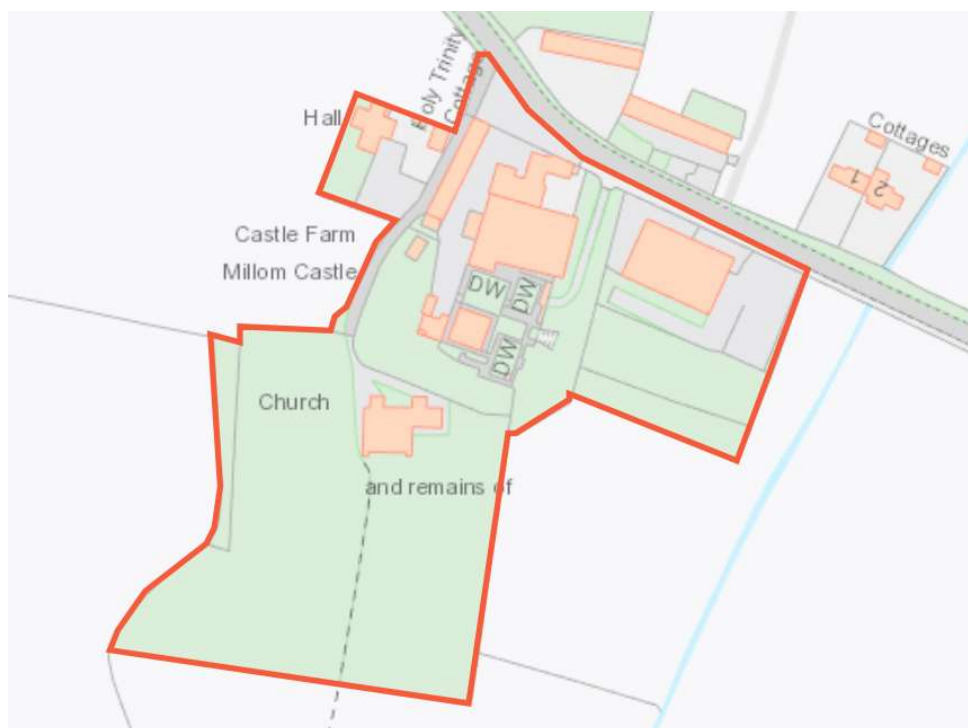
Figure 2 Conservation area boundary. Approx. area 2.3 ha.

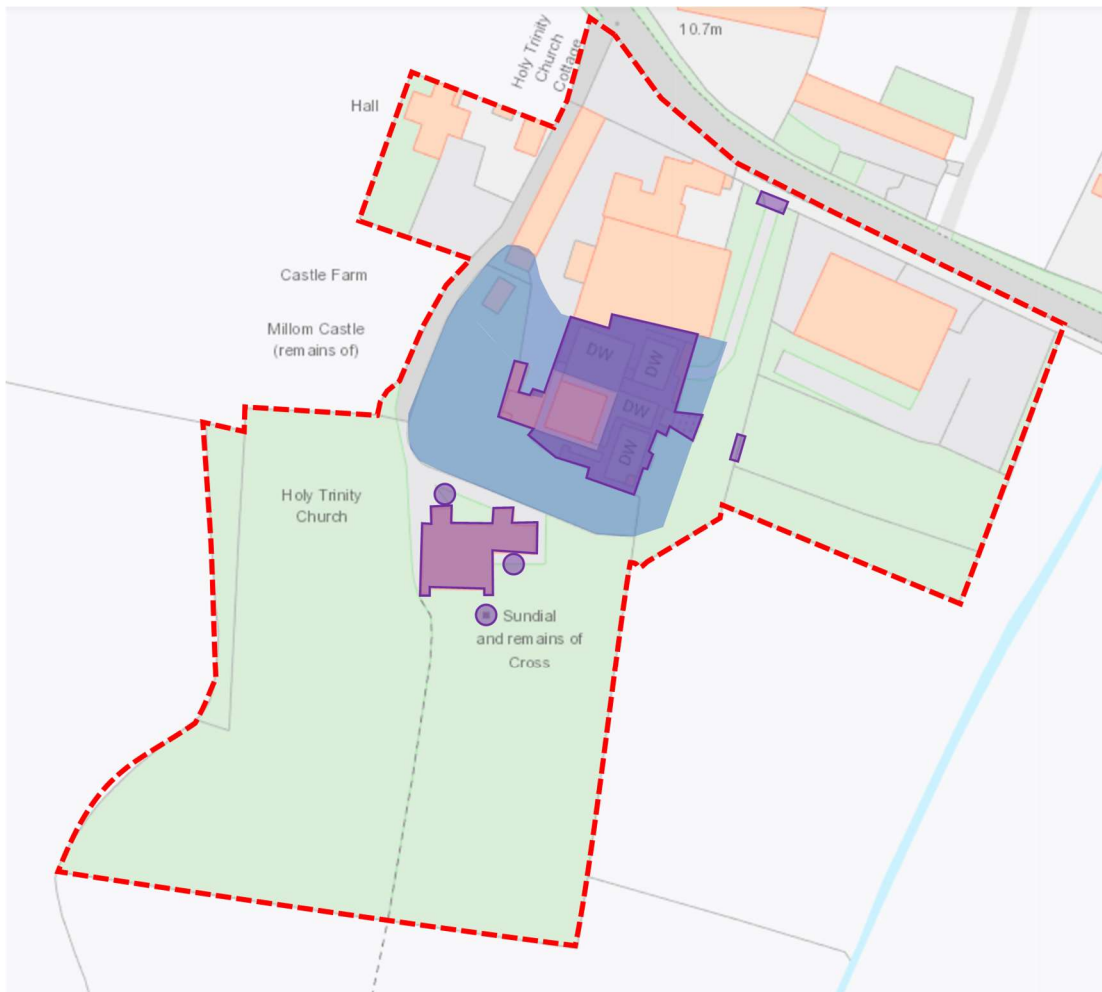
Figure 7 The area as it appears today, with listed buildings (purple)¹ and scheduled monument (blue) highlighted. A modern farm building has been inserted to the north-east of the castle, but very little has otherwise changed in the last century

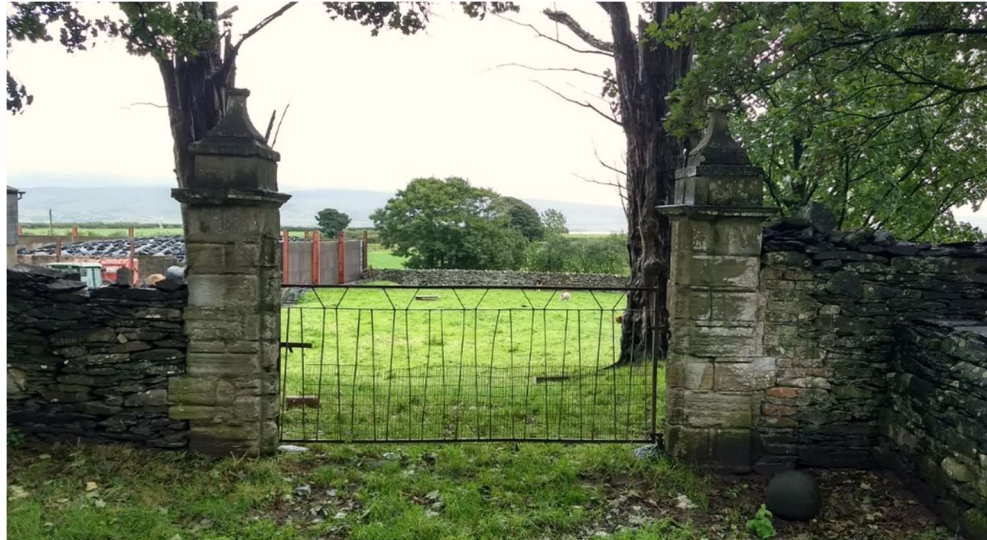
- Additionally, two sets of stone gate piers dating from the 17th or 18th centuries – conceivably contemporary with the last major round of repairs the castle received in 1670 – are to be found in the east and north boundaries of the area. Both are grade II listed.

Figure 8 One of the pairs of grade II listed gate piers, to the east of the castle ruins

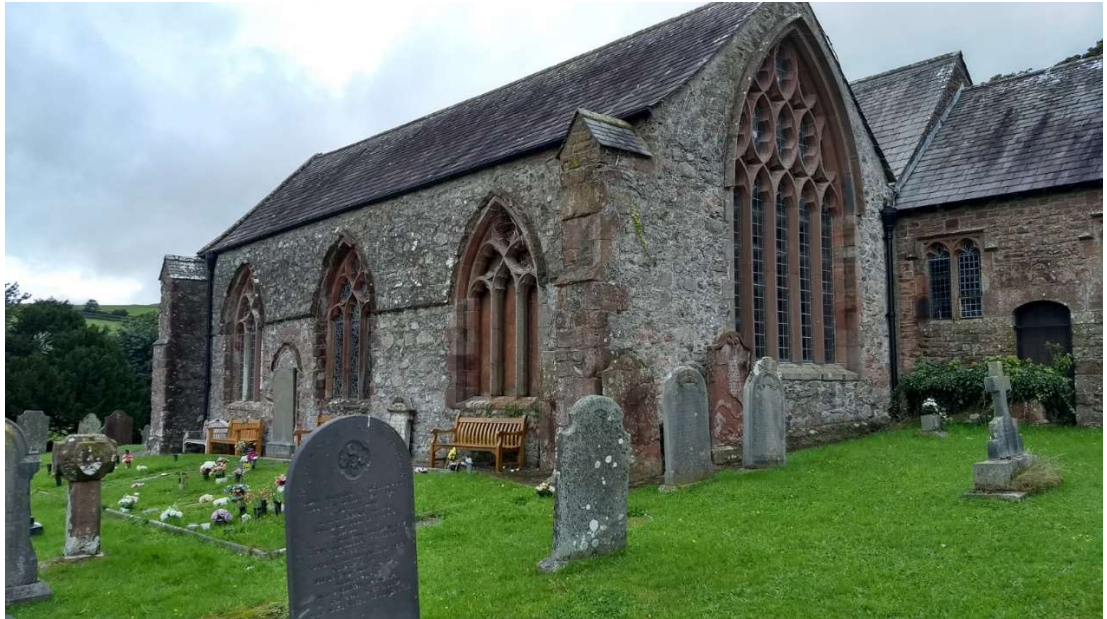
- A Grade I listed example that appears to have escaped the 19th century tendency for heavy-handed restoration, but has nonetheless changed quite considerably over its existence. Holy Trinity's fabric dates principally from the 12th, 13th and 14th centuries, with major work in the late 1850s and the 1930s.

- Roof is slate, with a gabled bell-cote.
- The west end contains evidence of a large, blocked arch, although it is not obvious how this was employed spatially or functionally.

- There is a blocked round-headed entrance on the south side.
- One of the church's most unusual features is its *vesica piscis*, or "fish bladder" window, so named for the Latin term for a fish's floatation bladder because of its shape. It is ten feet tall and seven across.

Figure 9 Holy Trinity Church from the south. The graveyard contains stones from a number of centuries, as well as a chest tomb, cross base and sundial that are listed in their own right.

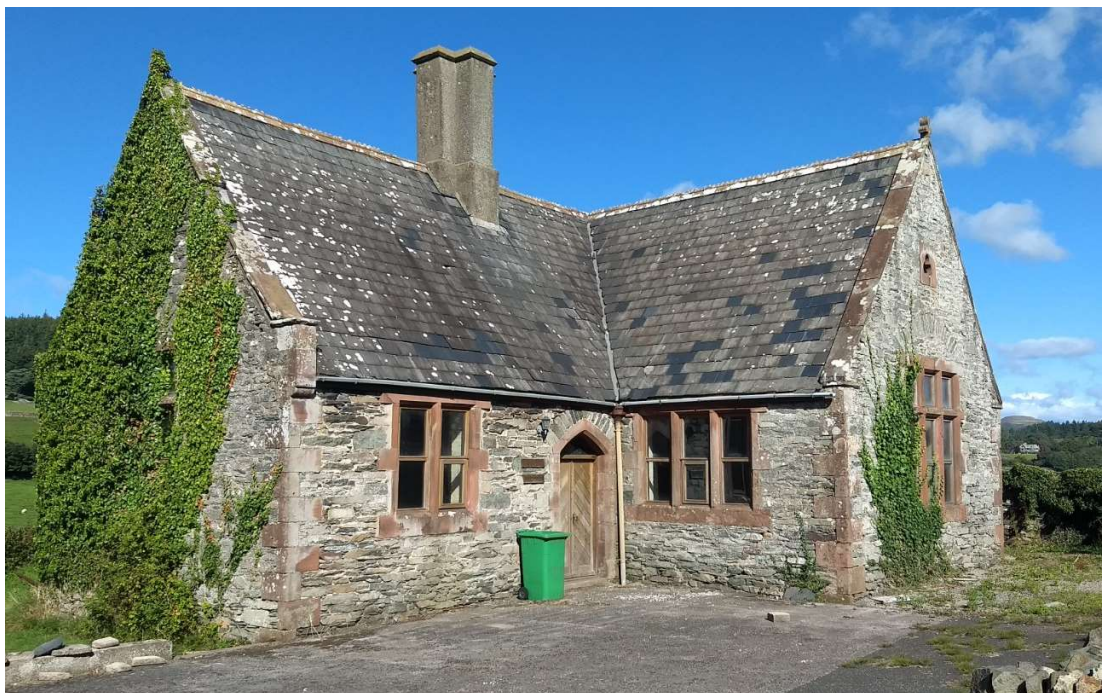
The schoolroom of 1858 is a handsome little stone building on a cross plan, with gothic revival elements such as the mullioned and transomed windows, fake stone window arches and monumental chimney stack. Although not listed, it is a non-designated heritage asset and of sufficient quality to sit comfortably alongside the other buildings.

Figure 10 The schoolroom

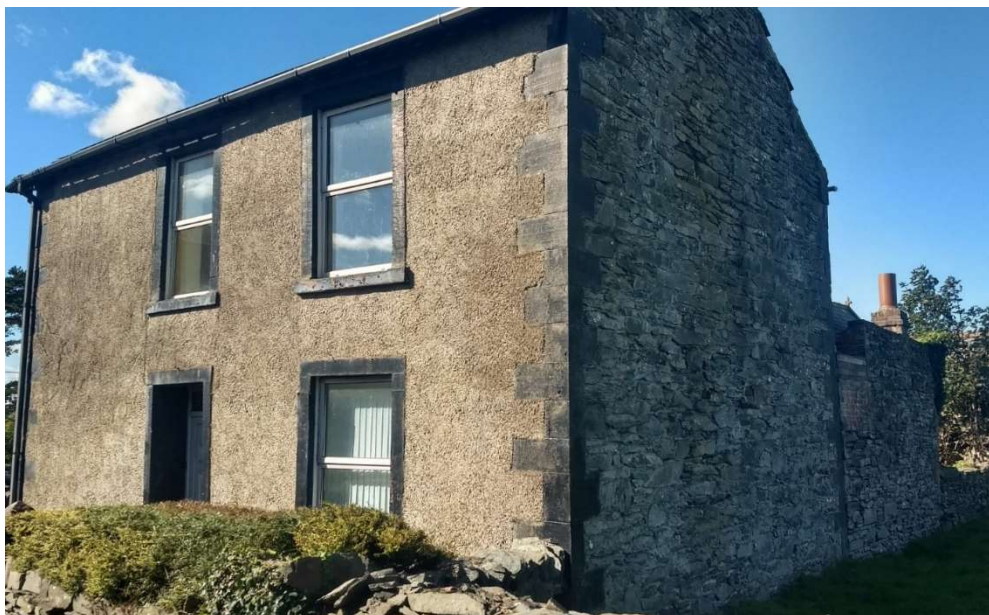
The headmaster's house was built slightly later than the schoolroom, sometime between the 1860s and 1890s. It is a small, two-storey house with end and intermediate chimney stacks and quoined corners in the style typical of late-19th century West Cumbrian cottages. To its west side is a single storey wash house connected to the cottage via a porch that acts as a link. The windows have been replaced with unattractive plastic units.

Figure 11 The headmaster's house

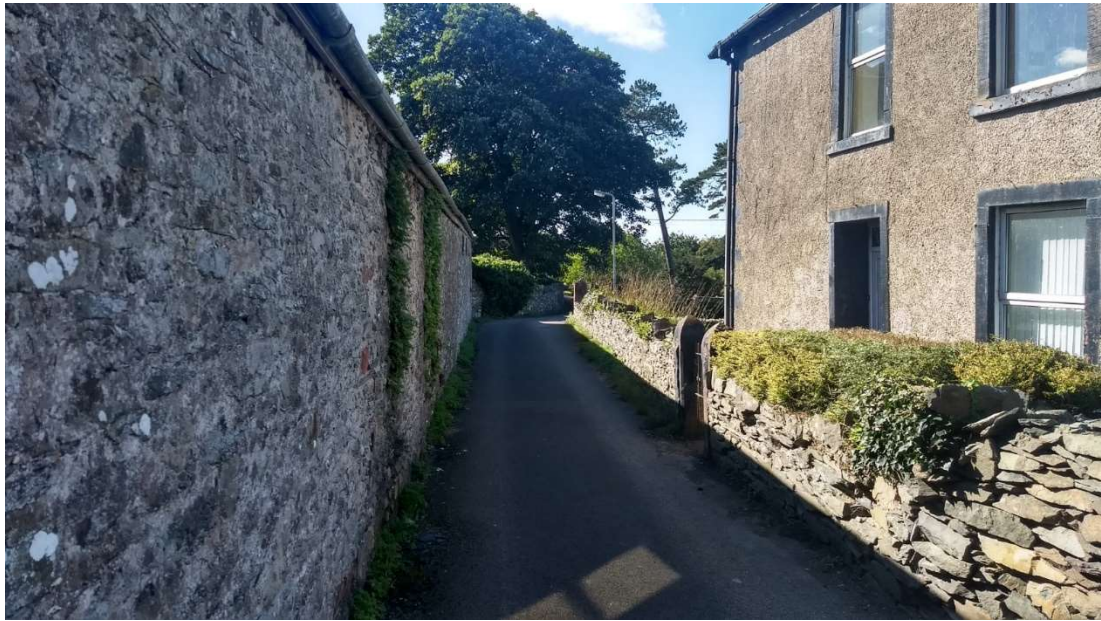
A lane leads from the roadside, between the byre and the Headmaster's House, down to the door of Holy Trinity Church. It is large enough to permit car access, but only just, and maintains the intimacy and intrigue of the area.

Figure 12 The lane that leads to the church between the headmaster's house (left) and the rear of the farmyard byre (right). The entrance to the Schoolroom car park is just past the headmaster's house on the right.

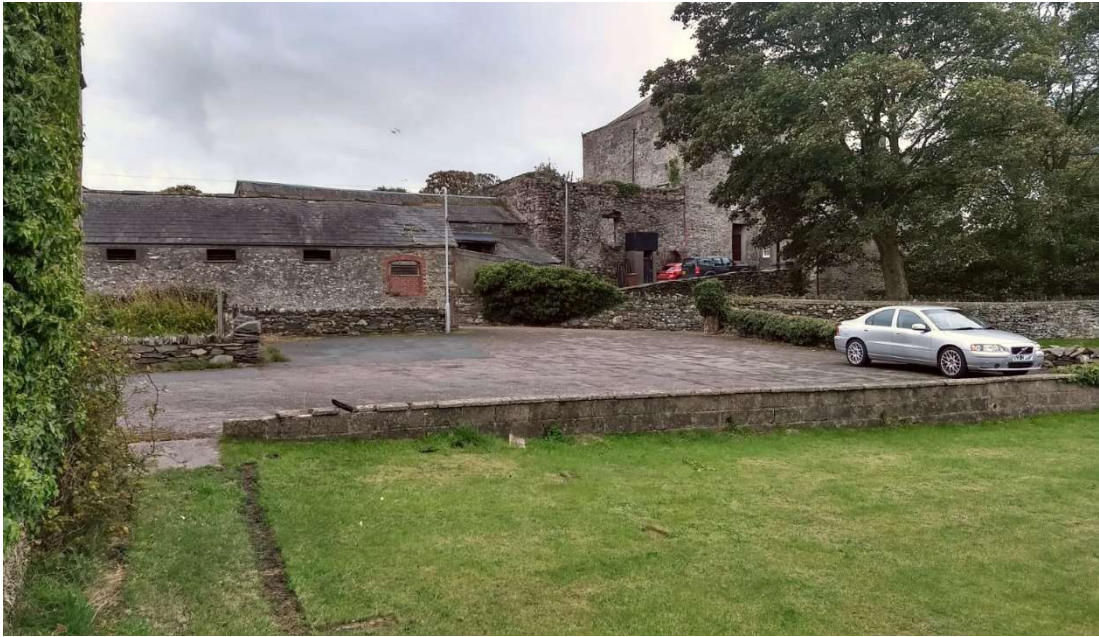
The schoolroom has a small grass curtilage to its south, and a tarmacked car park that, while no aesthetic contributor, does greatly improve access by car to the conservation area.

Figure 16 The car park at the schoolroom does not make a positive contribution to the character and appearance of the area, but it is well concealed and very useful given the site's relative inaccessibility

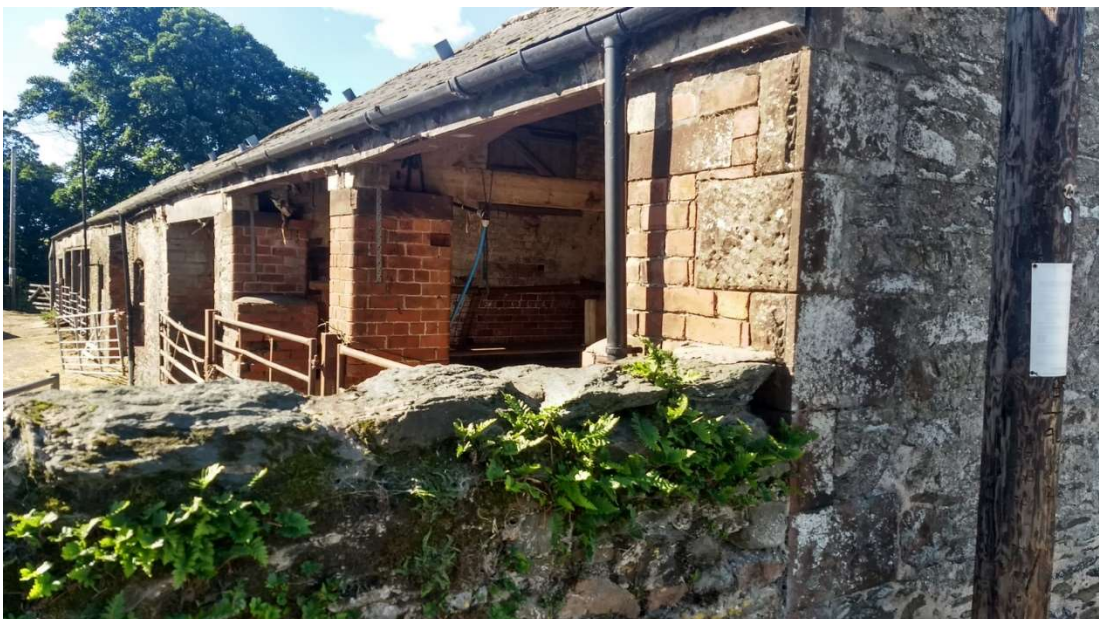
Figure 18 This old wall adjacent to the byre has small ferns growing in the top that enhance its character. Plants can, however, cause damage in masonry when left unchecked.

Care should be taken, however, that self-seeded saplings don't cause further damage to the masonry. A substantial young tree is already visible high in the south-east corner of the castle ruins, and will be causing further damage with every growth season.

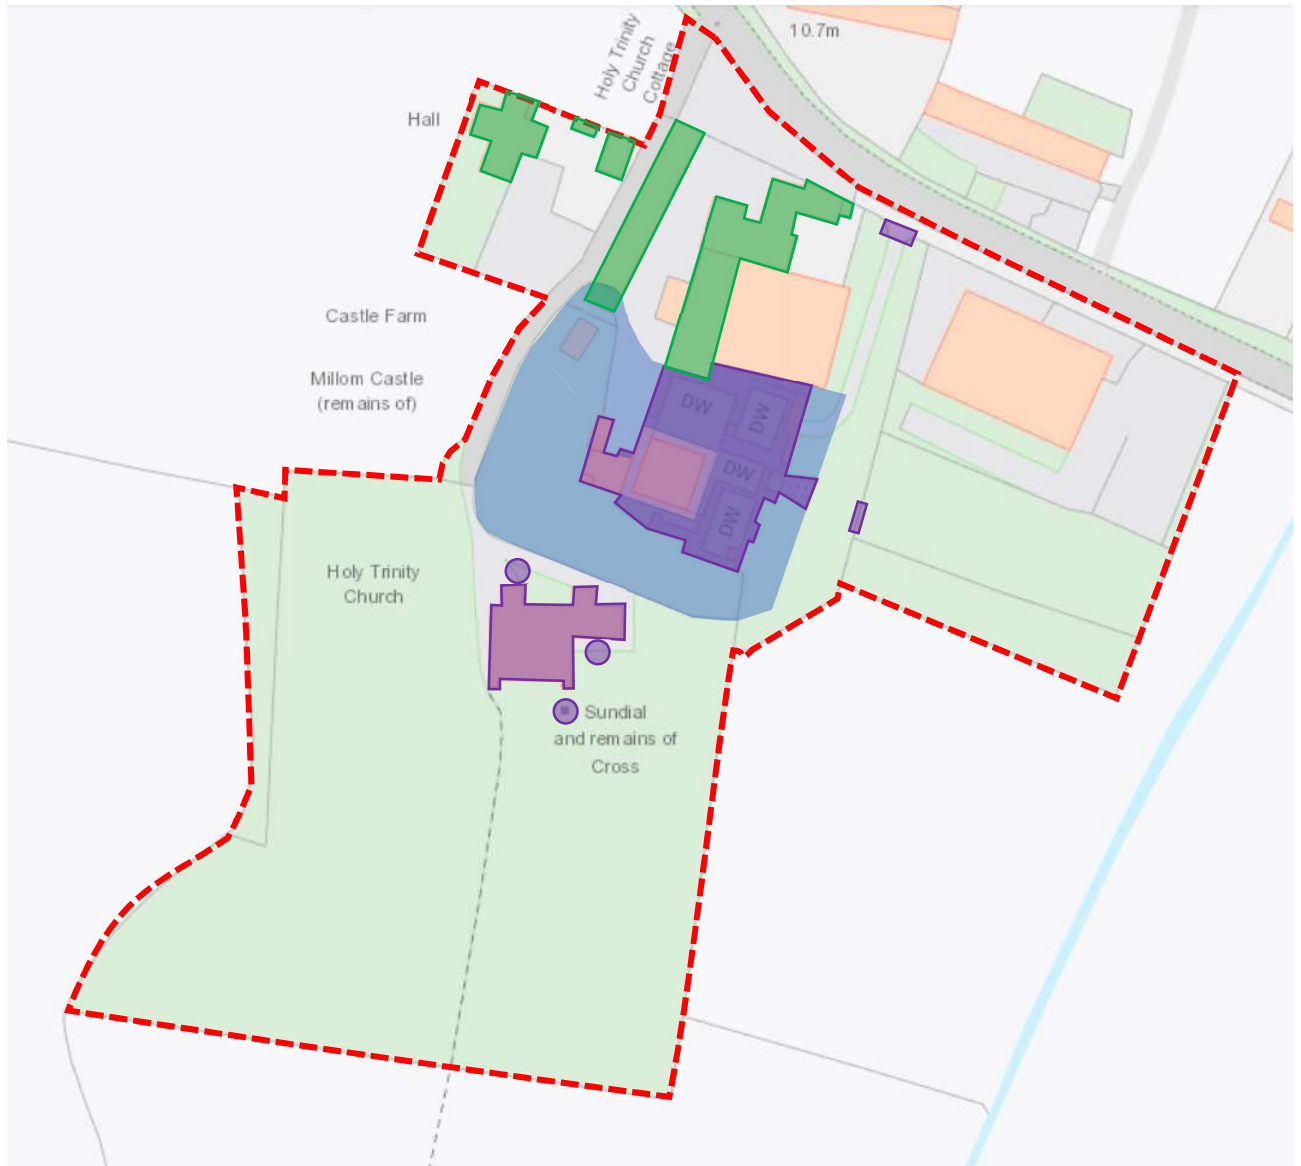
Figure 20 Map of conservation area showing boundary (red dashed), listed buildings (purple), scheduled monuments (blue), and non-designated heritage assets² (green)
